Date of Issue: 20 September 2002
Report No: QRH02-4236
Client: Lanotec
Attention: Geoff Boyle
Address PO Box 360
Archerfield QLD 4108
Order No. 248
Job Description: Adhesion Testing of Coating Systems After Water Miscible RA1 Lanolin Was Applied to Concrete Formwork.

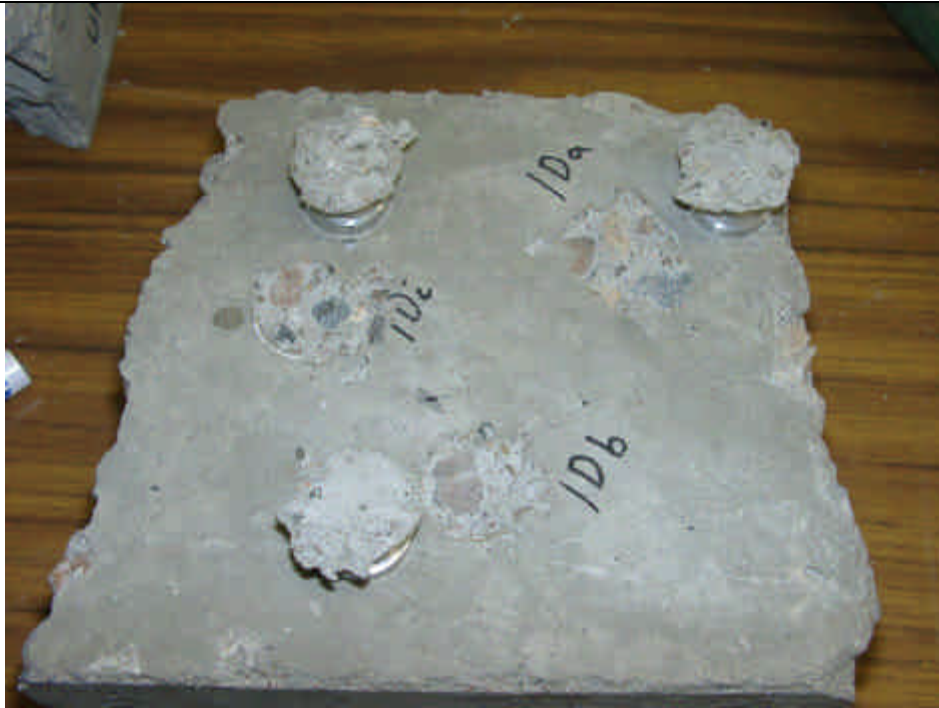
Figure 1 04080003
View of sample 1 (degreased) after dolly adhesion testing showing cohesive failure of the concrete substrate.

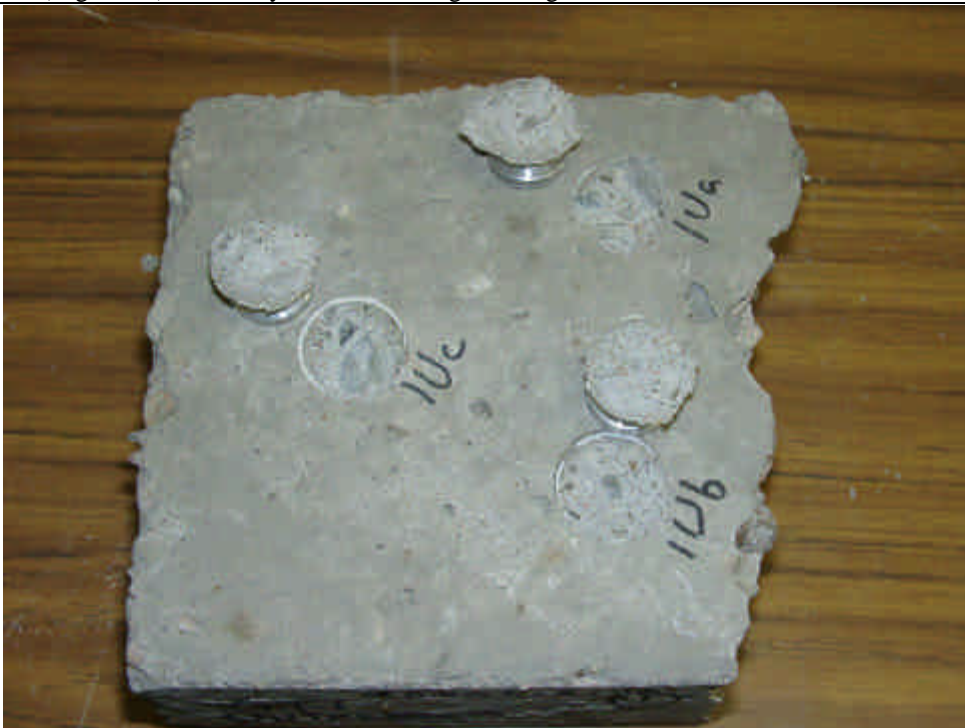
Figure 2 04080007
View of sample 1 (untreated) after dolly adhesion testing showing cohesive failure of the concrete substrate.

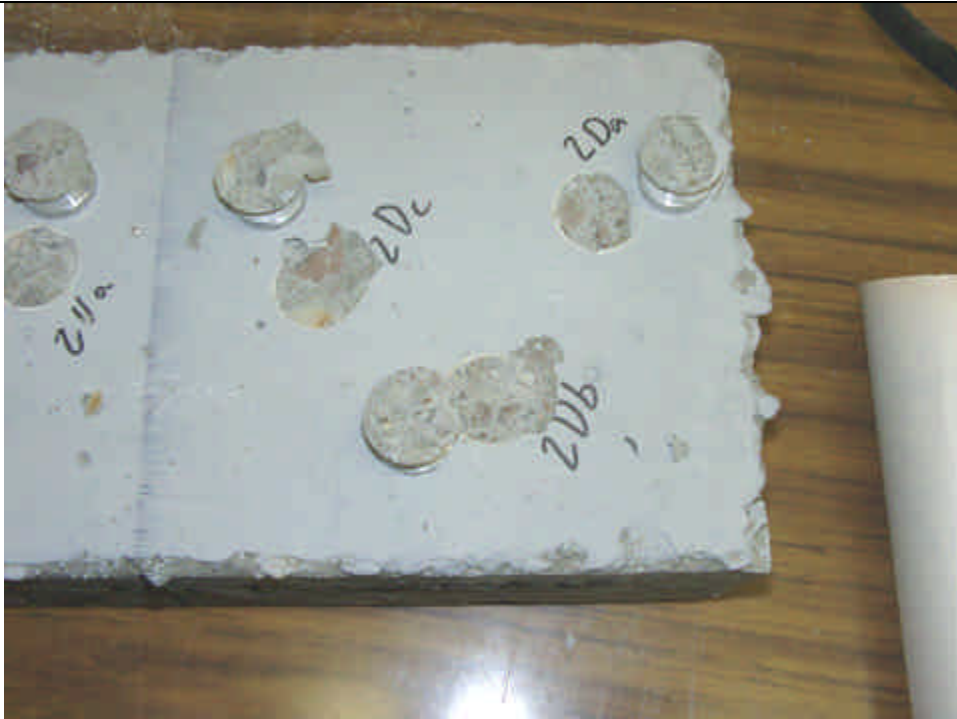
Figure 3
View of sample 2 (degreased) after dolly adhesion testing showing cohesive failure of the concrete substrate.

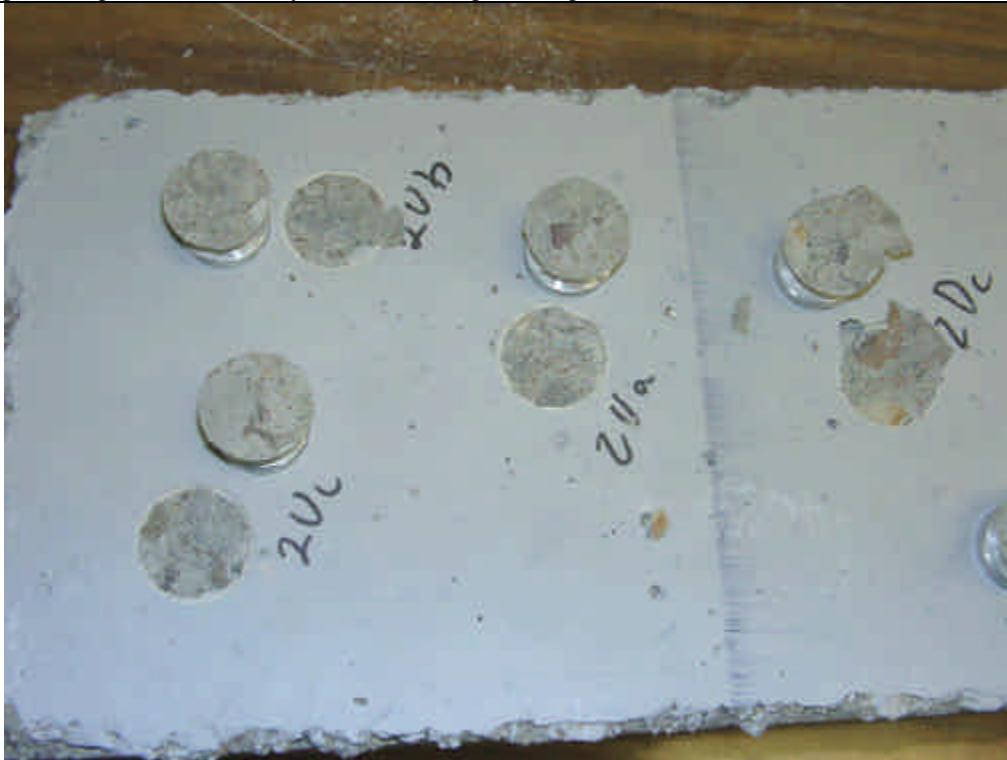
Figure 4
View of sample 2 (untreated) after dolly adhesion testing showing cohesive failure of the concrete substrate.

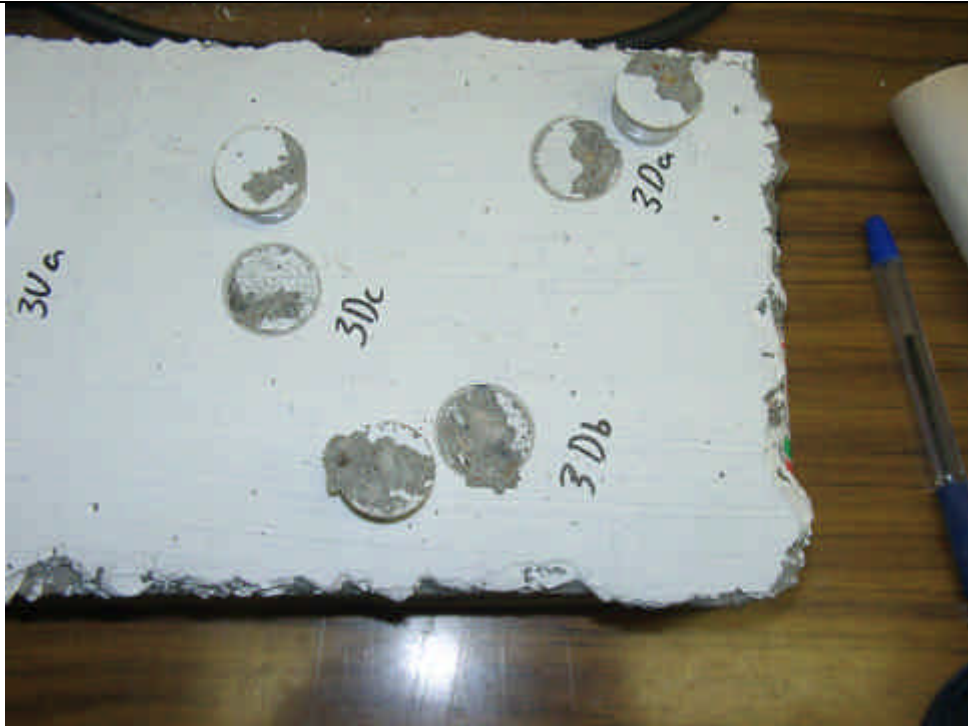
Figure 5

View of sample 3 (degreased) after dolly adhesion testing showing cohesive failure of the concrete substrate and coating. Figure shows no adhesive failure of the coating system.

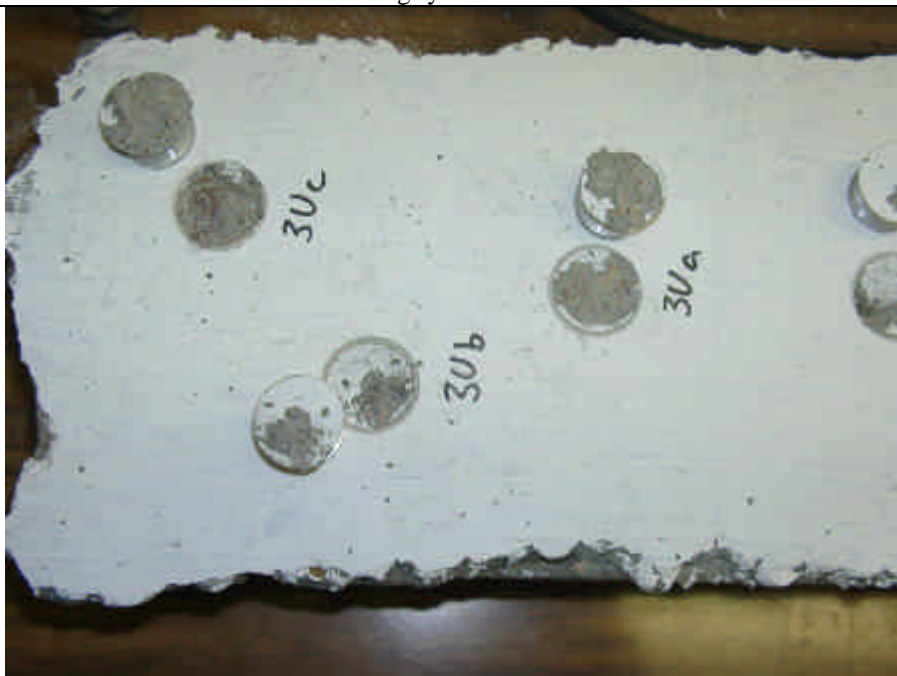
Figure 6

View of sample 3 (untreated) after dolly adhesion testing showing cohesive failure of the concrete substrate and coating. Figure shows no adhesive failure of the coating system.

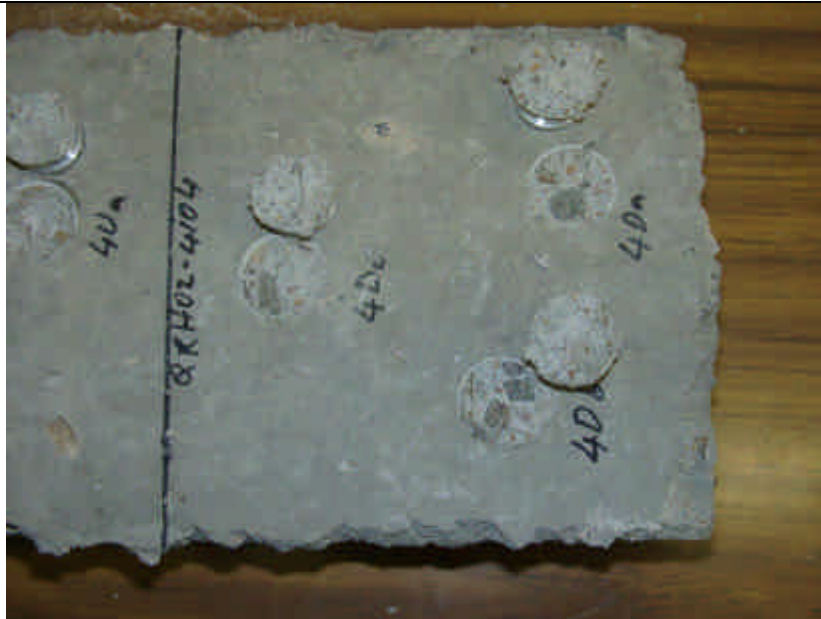
Figure 7 04080029
View of sample 4 (degreased) after dolly adhesion testing showing cohesive failure of the concrete substrate.

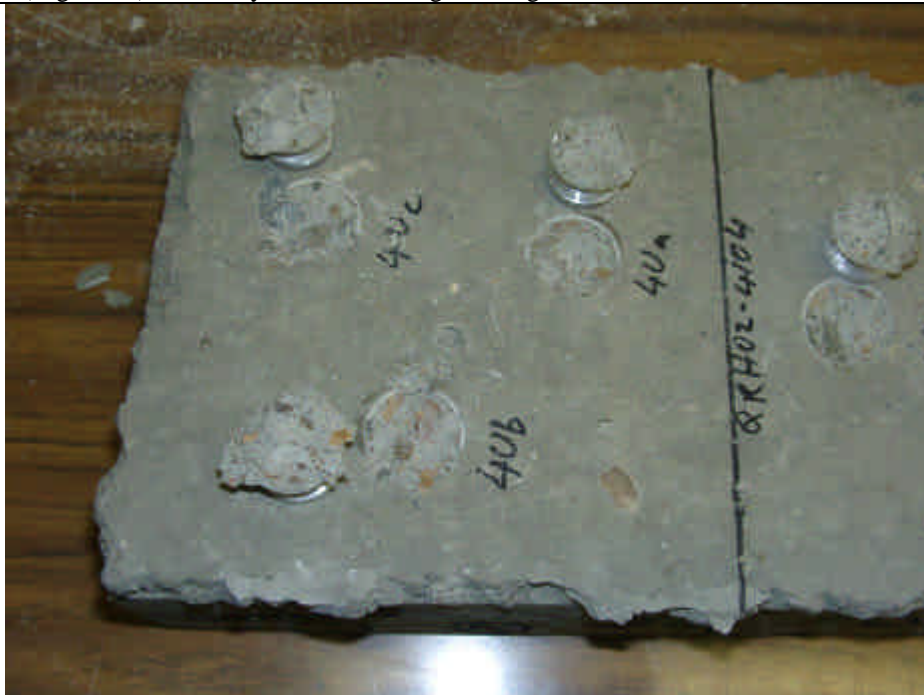
Figure 8 04080033
View of sample 4 (untreated) after dolly adhesion testing showing cohesive failure of the concrete substrate.

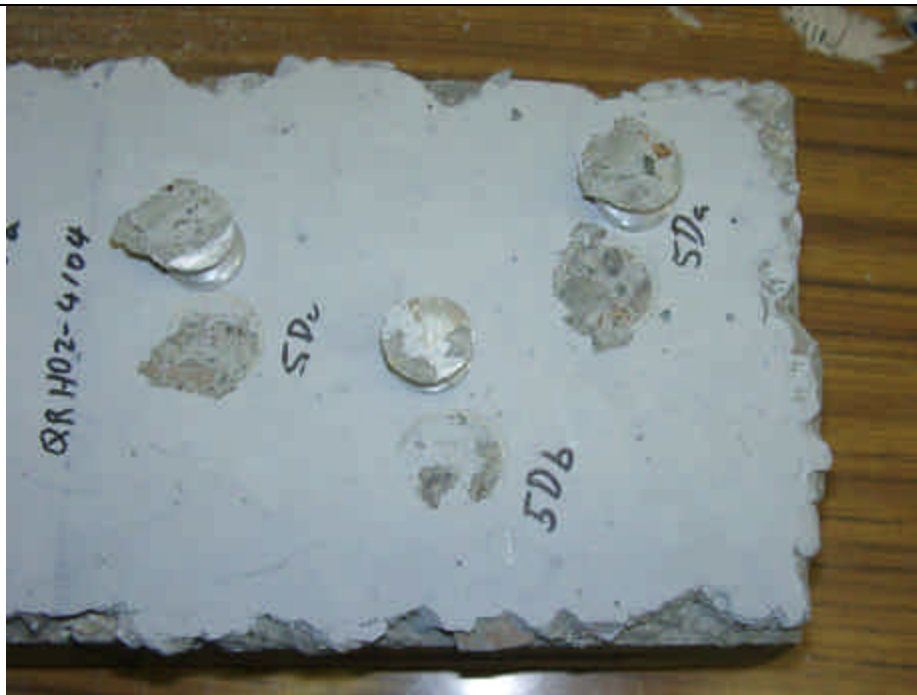
Figure 9

View of sample 5 (degreased) after dolly adhesion testing showing cohesive failure of the concrete substrate. Test point 5Db shows the glue used to adhere the dolly to the coating had failed. Figure shows no adhesive failure of the coating system.

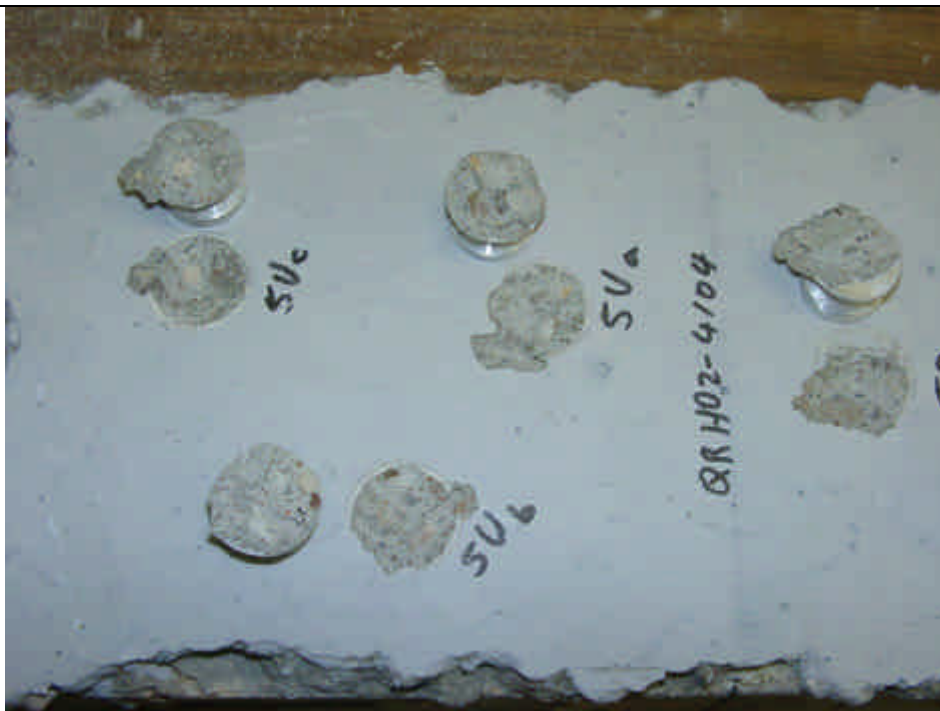
Figure 10

View of sample 5 (untreated) after dolly adhesion testing showing cohesive failure of the concrete substrate. Figure shows no adhesive failure of the coating system.

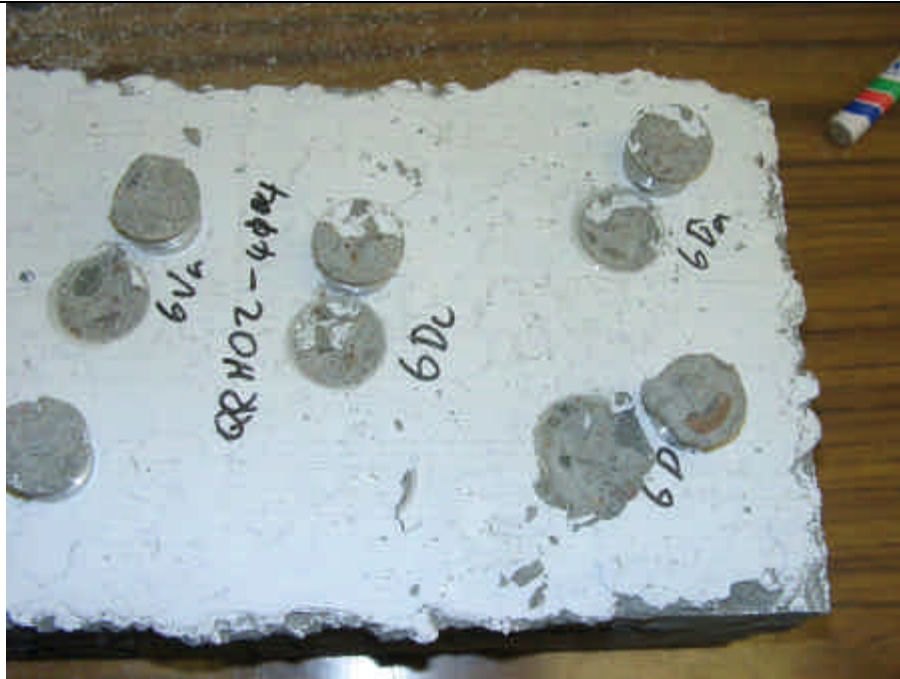
Figure 11

View of sample 6 (degreased) after dolly adhesion testing showing cohesive failure of the concrete substrate and coating. Figure shows no adhesive failure of the coating system.

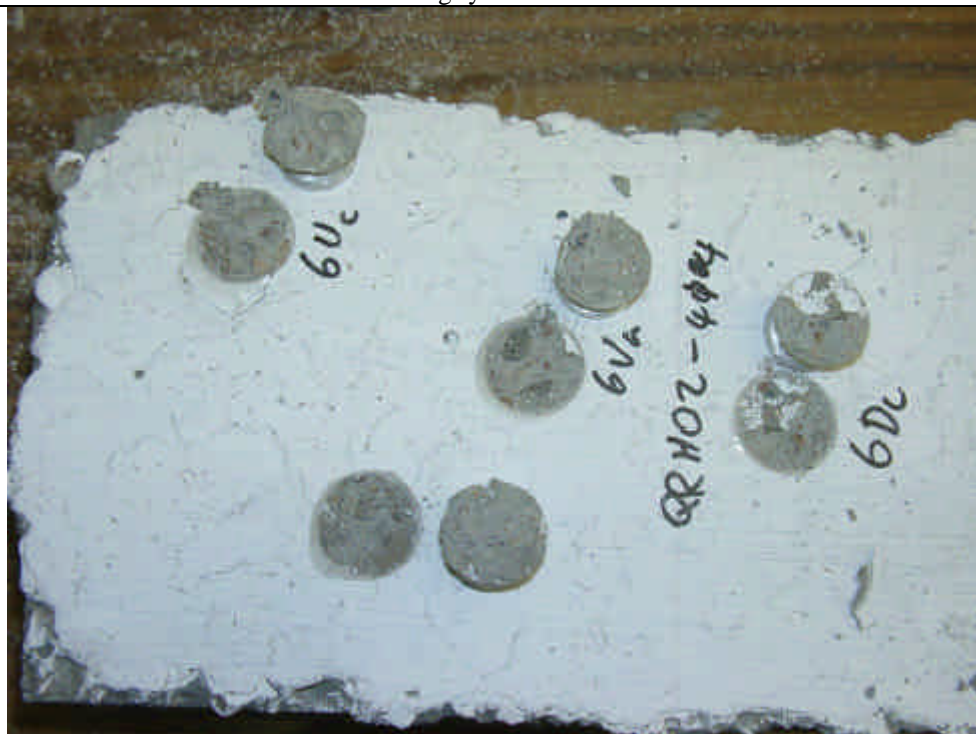
Figure 12

View of sample 6 (untreated) after dolly adhesion testing showing cohesive failure of the concrete substrate. Figure shows no adhesive failure of the coating system.
