**Date of Issue:** 09 March 2004  
**Report No:** QRH04-4024  
**Client:** Lanotec Australia Pty Ltd  
**Attention:** Geoff Boyle  
**Address** PO Box 360  
Archerfield Qld 4108  
**Order No.** 724  
**Job Description:** Testing of Lanolin based products applied to Powder Coated Aluminium in the Presence of Mortar

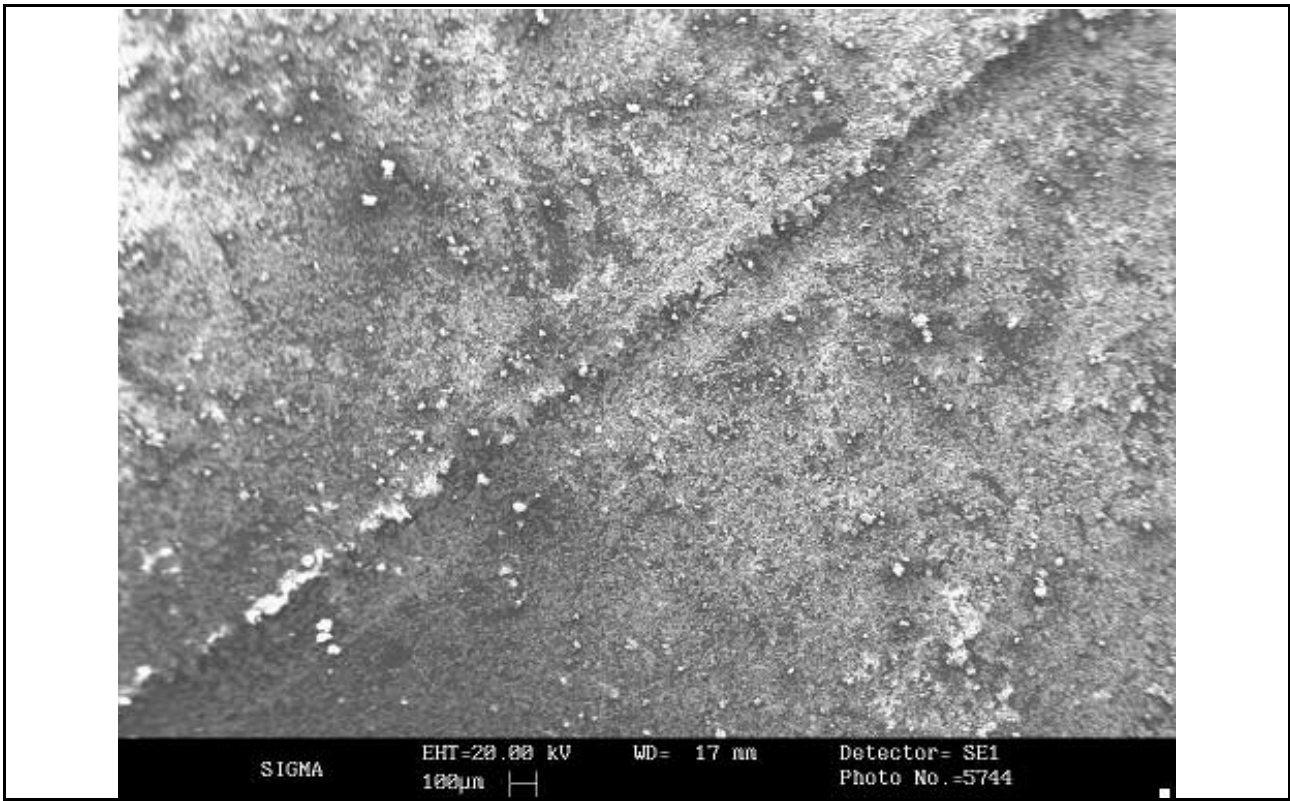
Figure 1 Scanning Electron Microscope (SEM) image of powder coated aluminium surface that has been scratched with knife, coated with Lanotec – GP21, and exposed to mortar and moist environment. No evidence of corrosion was observed after 9 days exposure.

- After 9 days exposure, evidence of aluminium corrosion was observed at the exposed metal surface (ie where 'x' cut had been made) for the 'no lanolin' section of test panel. No evidence of corrosion could be detected for the corresponding area of the 'lanolin' coated area.

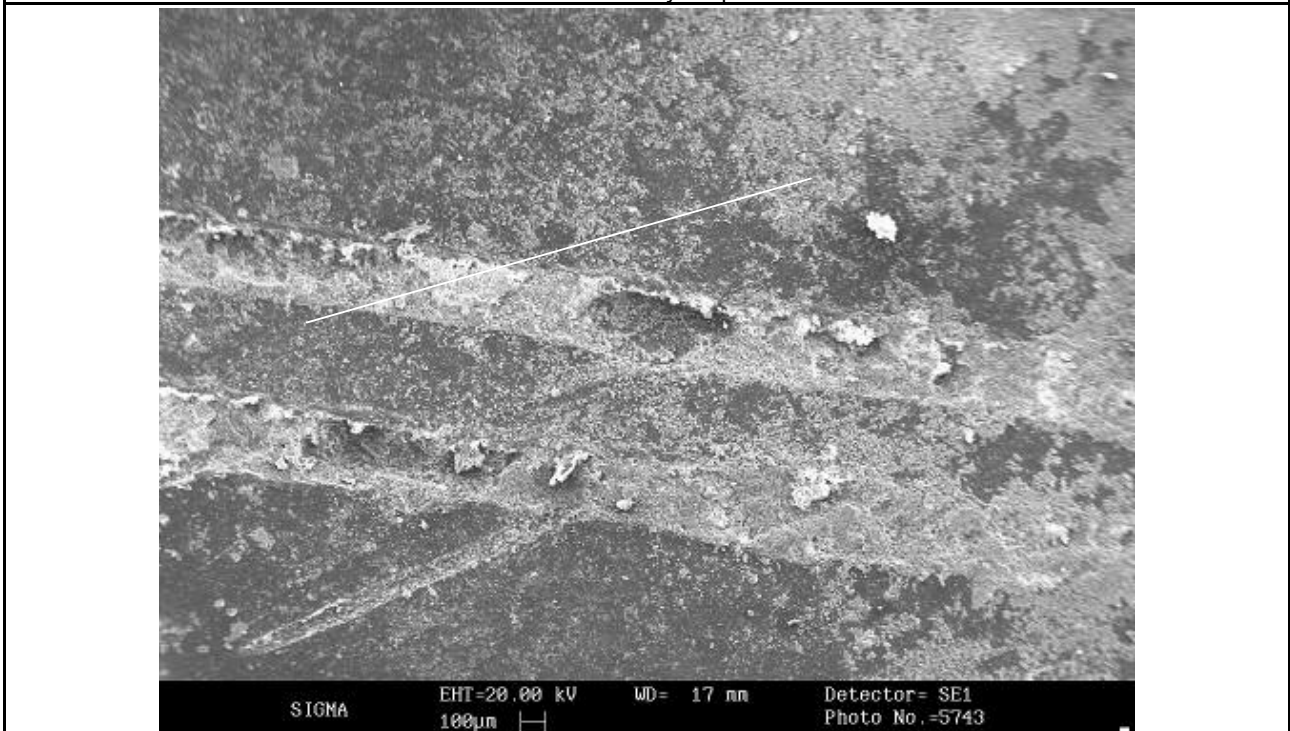
Figure 2 Scanning Electron Microscope (SEM) image of powder coated aluminium surface that has been scratched with knife and exposed to mortar and moist environment. Evidence of corrosion was observed after 9 days exposure.

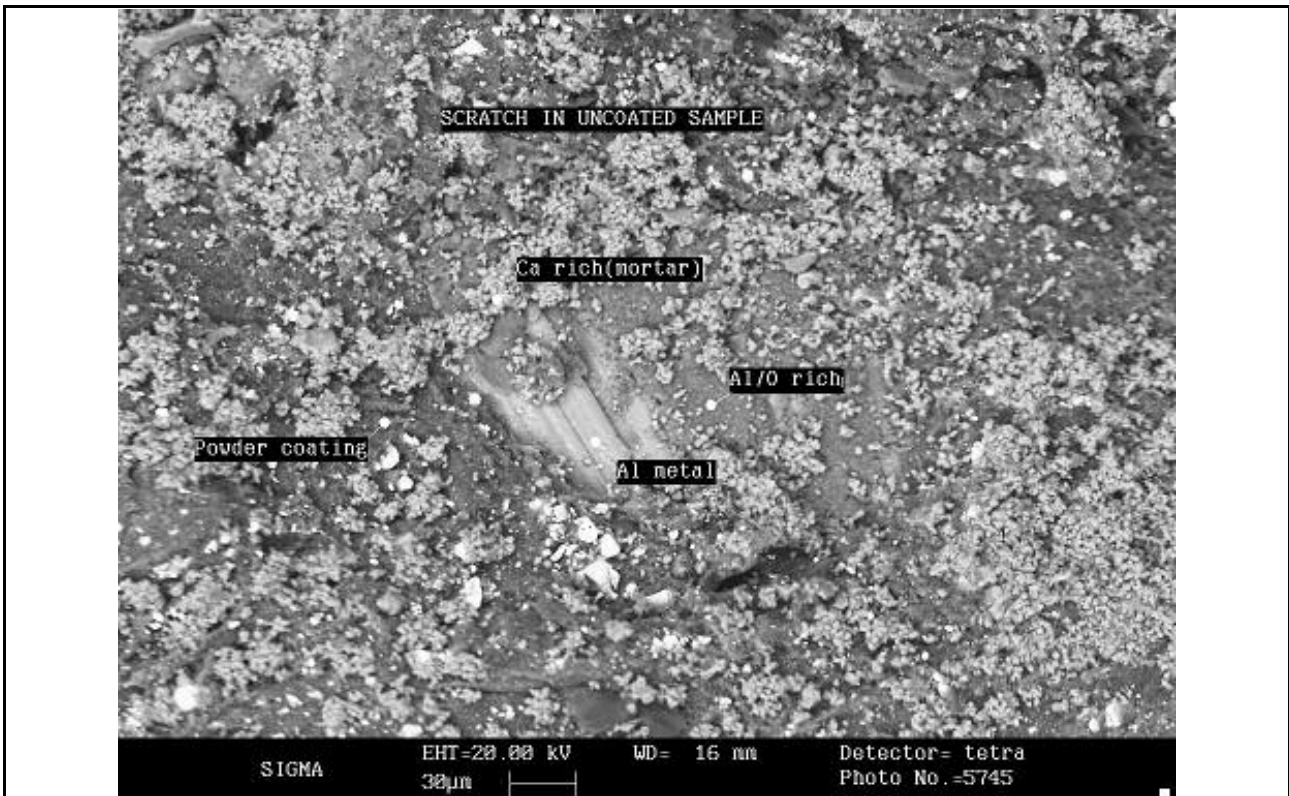
Figure 3 As per Figure 2 – higher magnification shows evidence of aluminium oxide produced by corrosion process.

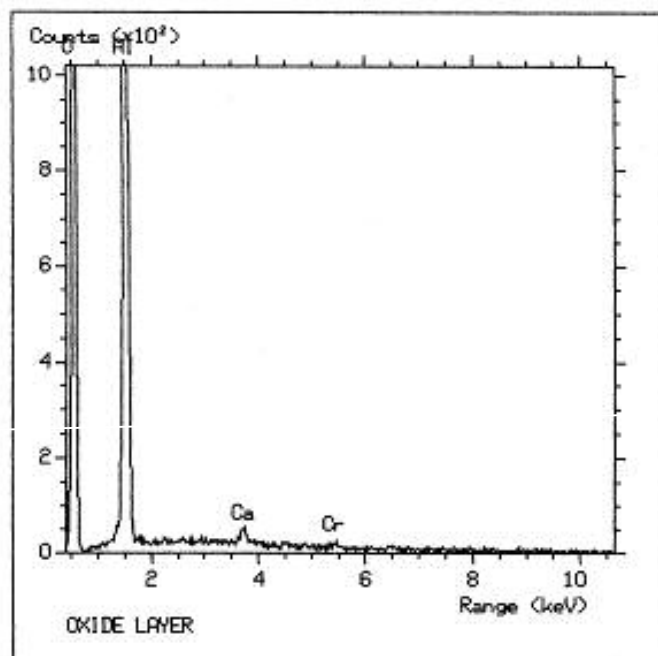
Figure 4 As per Figure 3 – chemical analysis of particle by Energy Dispersive Analysis of X Rays (EDAX) indicates Aluminium oxide rich corrosion product.
